TECHNICAL ASSISTANCE TEAM FOR EMERGENCY RESPONSE REMOVAL AND PREVENTION
EPA CONTRACT 68-01-7367

Re: Interstate Pollution Control, Rockford, Illinois
TDD# 5-8911-22

FIGURE 2
SITE MAP WITH SAMPLE LOCATIONS
INTERSTATE POLLUTION CONTROL
ROCKFORD, ILLINOIS

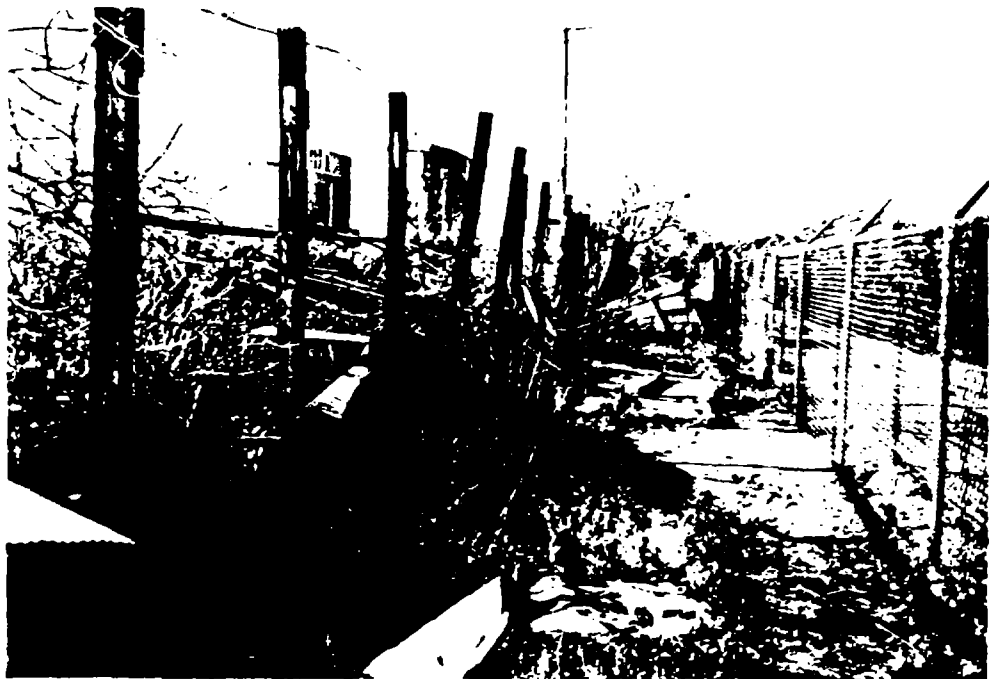
PHOTO: 3
 SITE: INTERSTATE POLLUTION CONTROL
 DESCRIPTION: WEST VIEW BROKEN FENCE, NORTH SIDE
 DATE/TIME: 12-5-89/1200
 PHOTOGRAPHER: LEN ZINTAK
 CAMERA: 35 mm

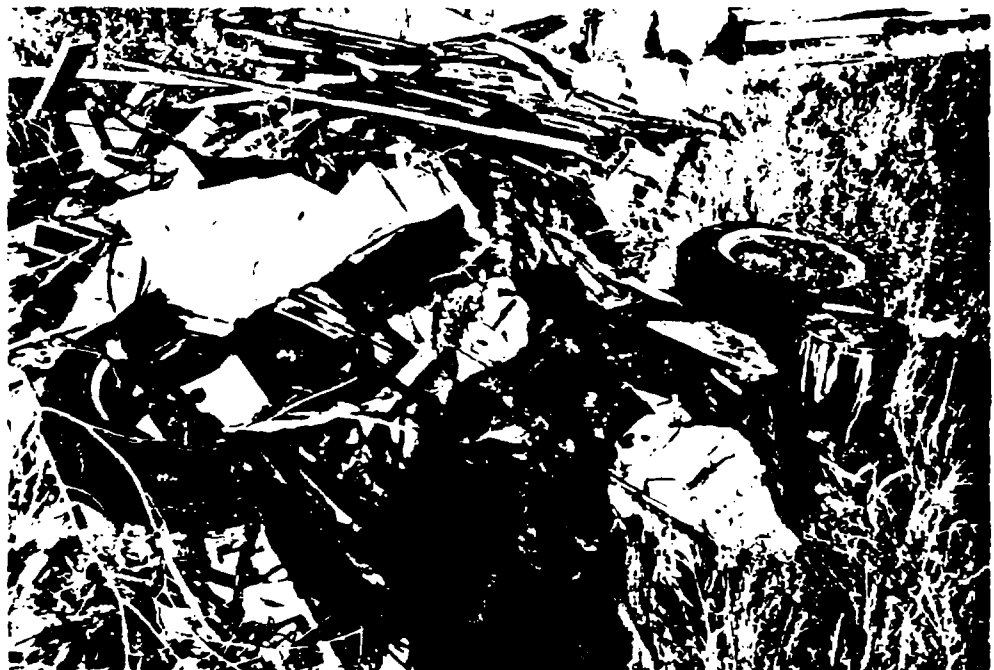
PHOTO: 4
 SITE: INTERSTATE POLLUTION CONTROL
 DESCRIPTION: 5 GALLON PAILS FOUND ON SITE
 DATE/TIME: 12-5-89/1115
 PHOTOGRAPHER: LEN ZINTAK
 CAMERA: 35 mm

Analytical results of the sample collected from the 5-gallon pail of industrial finish indicated total cyanide of 0.715 ppm, total sulfide of 0.579 ppm, a pH of 5.7 and a flash point of 65 degrees (°) Fahrenheit (F). The material sampled would be considered a hazardous waste based on the Resource Conservation and Recovery Act (RCRA) characteristic of ignitability (<140°F).

The pail contents sampled by the TAT indicated a flash point of 65°F, presenting a fire or explosion threat. In addition, an explosion or fire could distribute hazardous particulate matter to nearby, uncontaminated areas.

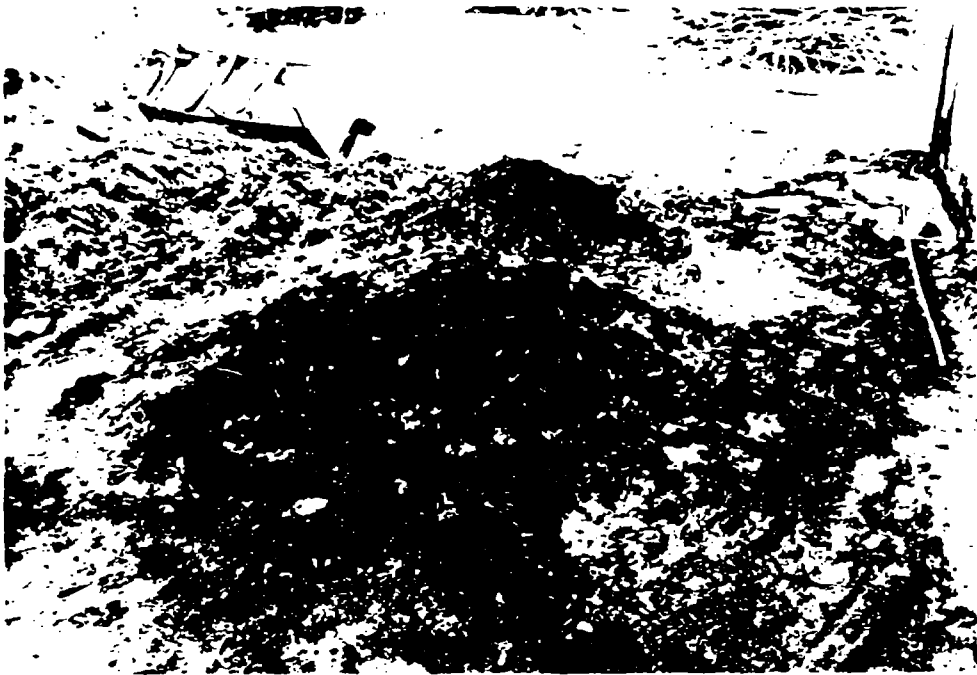
PHOTO: 1
 SITE: INTERSTATE POLLUTION CONTROL
 DESCRIPTION: STAINED SOIL NORTH OF BUILDING
 DATE/TIME: 12-5-89/1145
 PHOTOGRAPHER: LEN ZINTAK
 CAMERA: 35 mm

Analytical results from the soil sampling are summarized in Table 1. Both the samples collected from the lagoon area (S72) and north of the on-site building (S73) indicated elevated levels of cadmium, chromium, total cyanide, lead, nickel and zinc when compared to the background sample (S74). The samples (S72 and S73) also contained benzylbutylphthalate, bis(2-ethylhexyl)phthalate, di-n-butylphthalate and naphthalene. The sample collected north of the on-site building (S73) additionally contained acenaphthylene, anthracene, dimethylphthalate, phenanthrene, 4-chloro-3-methylphenol and phenol. PCBs were not detected above method detection limits and EP tox metals were all below the maximum concentration.

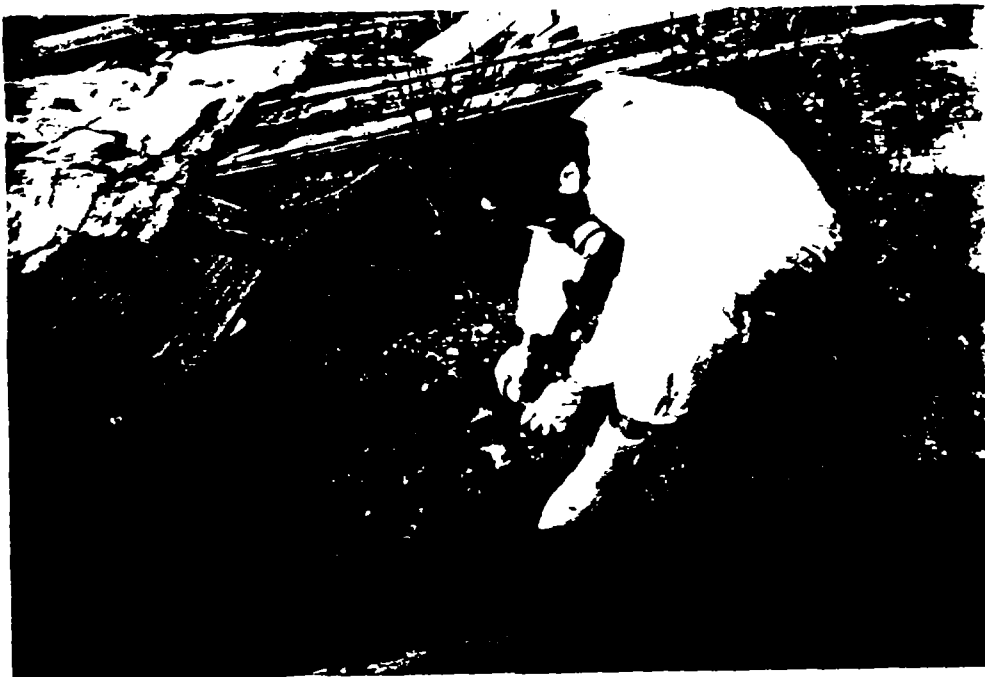
PHOTO: 2
 SITE: INTERSTATE POLLUTION CONTROL
 DESCRIPTION: SAMPLING SOIL AT LAGOON AREA
 DATE/TIME: 12-5-89/1130
 PHOTOGRAPHER: LEN ZINTAK
 CAMERA: 35 mm

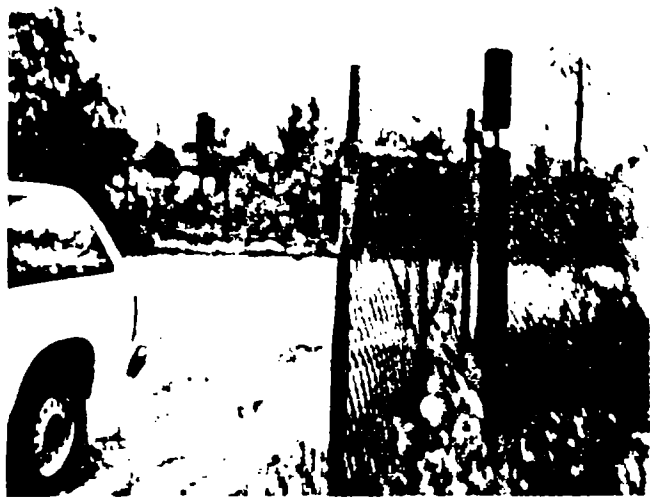
PHOTO: 1
 SITE: INTERSTATE POLLUTION CONTROL
 DESCRIPTION: EAST VIEW OF OPEN GATE
 DATE/TIME: 10-10-89/ 1000 HRS
 PHOTOGRAPHER: M. PIRO
 CAMERA: INSTAMATIC 126

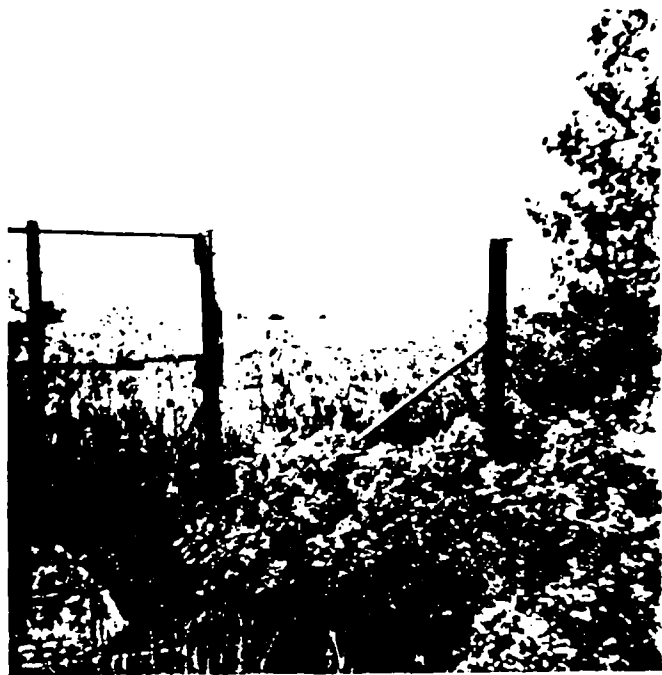
On October 11, 1989, after reviewing the IPC NPL site files, the TAT conducted a perimeter site investigation at IPC (TDD#5-8908-26). The TAT observed that the fence on the south side of the site was not intact. Residential and industrial wastes were observed around the site. Stained surface soil was observed near the 100,000 gallon storage tank. Drums were observed in the on-site building. Based on these observations, it was determined that an additional site investigation was necessary.

PHOTO: 2
 SITE: INTERSTATE POLLUTION CONTROL
 DESCRIPTION: SOUTH VIEW BROKEN FENCE
 DATE/TIME: 10-10-89/ 1000 HRS
 PHOTOGRAPHER: M. PIRO
 CAMERA: INSTAMATIC 126
